National Technical Information Service 5285 Fort Royal Reed Springfield, Virginia 22161 INSTALLATION RESTORATION PROGRAM RECORDS SEARCH

RICHARDS-GEBAUR AIR FORCE BASE, MISSOURI

March 1983

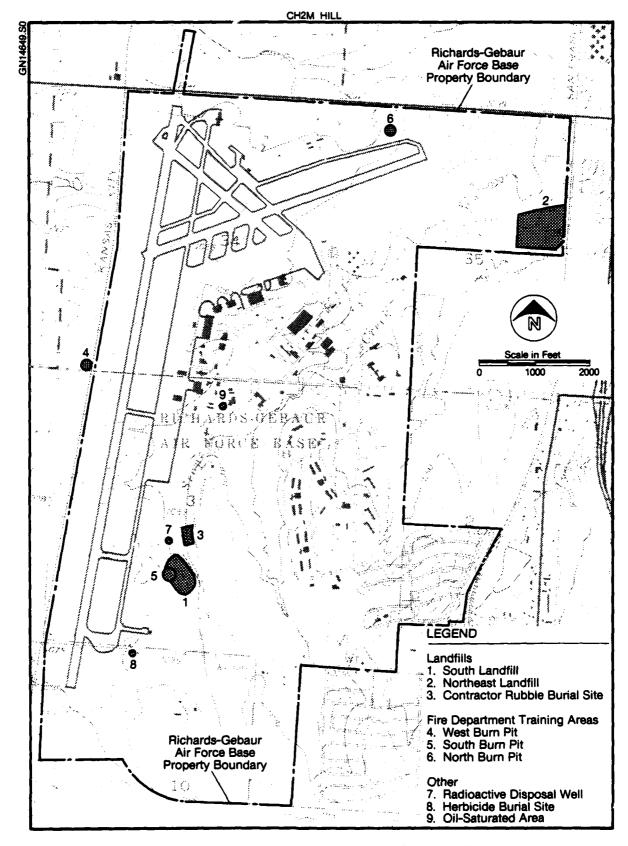
FIGURE 6. Identified disposal sites, Richards-Gebaur AFB, Missouri.

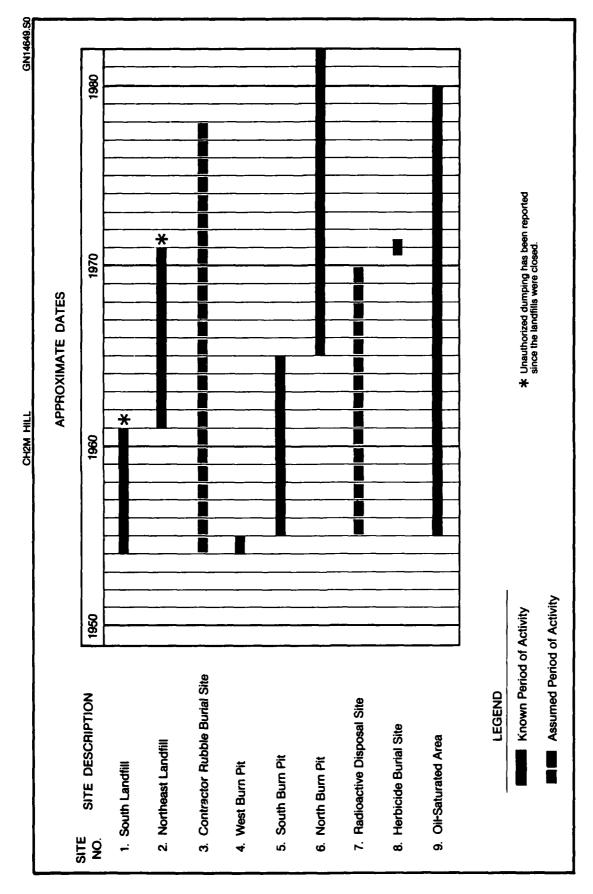
FIGURE 7. Historical summary of activities at major disposal sites.
